CANONSBURG DAM No. 2 (JOHNSONS RUN DAM)
~~WASHINGTON COUNTY, COMMONWEALTH OF PENNSYLVANIA~~

NDI Number PA 00506

PHASE I INSPECTION REPORT
NATIONAL DAM INSPECTION PROGRAM

Canonsburg Dam No. 2 (Johnsons Run Dam)
Washington County, Pennsylvania
NDI No. PA 00506, PennDER No. 63-41
Inspected 4 December 1979

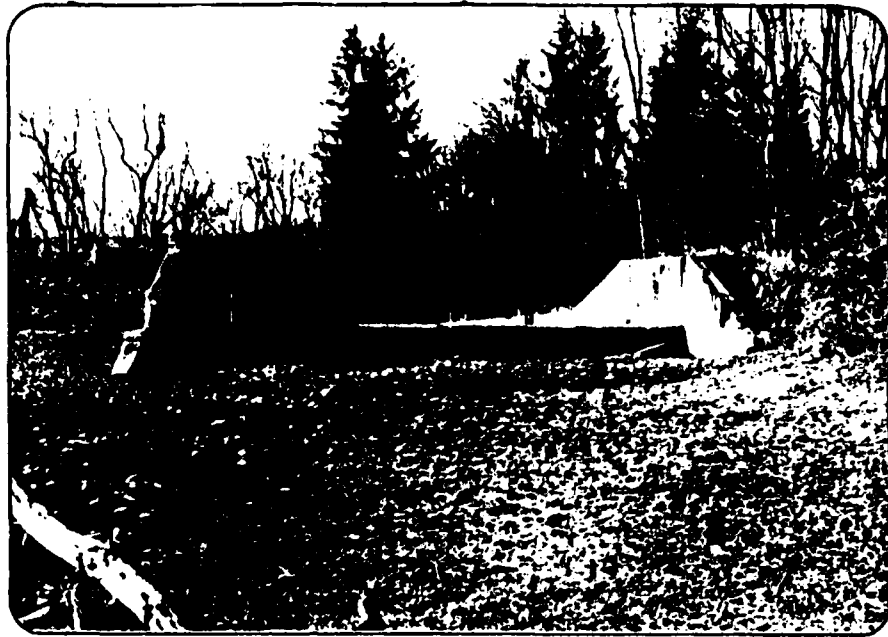
- 1) At the entrance to the spillway on both training walls, severe spalling of the concrete at the normal pool level has occurred.
- 2) The vertical construction joints of the chute channel walls are spalled in a few places and generally the joints are in need of minor repair.

The approach channel is acceptable except that on both sides of the upstream end of spillway training walls at the water (or ice) level the concrete is spalled and deteriorated (see Photo 1).

PHOTO 1. View of Spillway Approach and Overflow Weir

These areas should be repaired to prevent further deterioration.

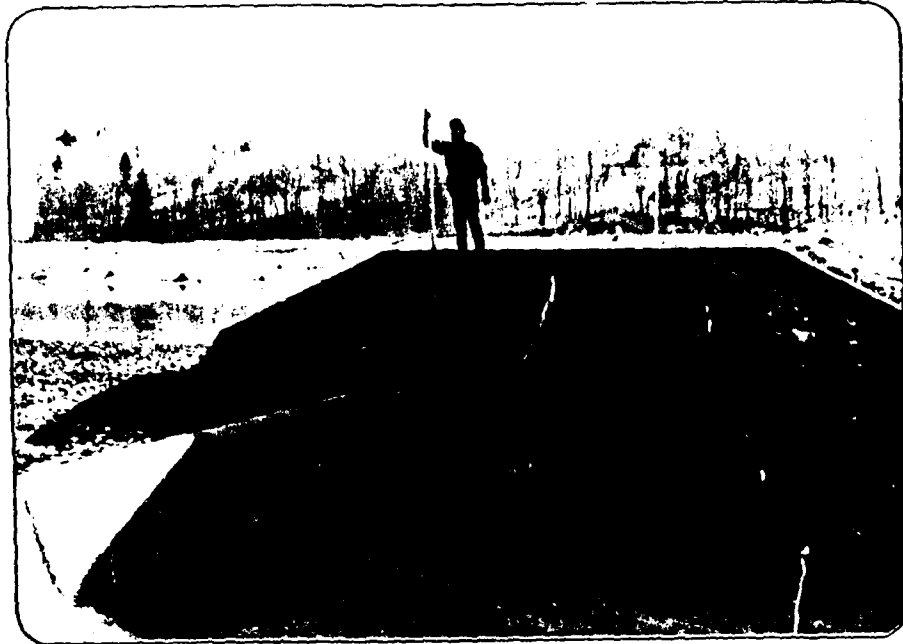
PHOTO 3. View of Spillway Overflow Weir and Training Wall

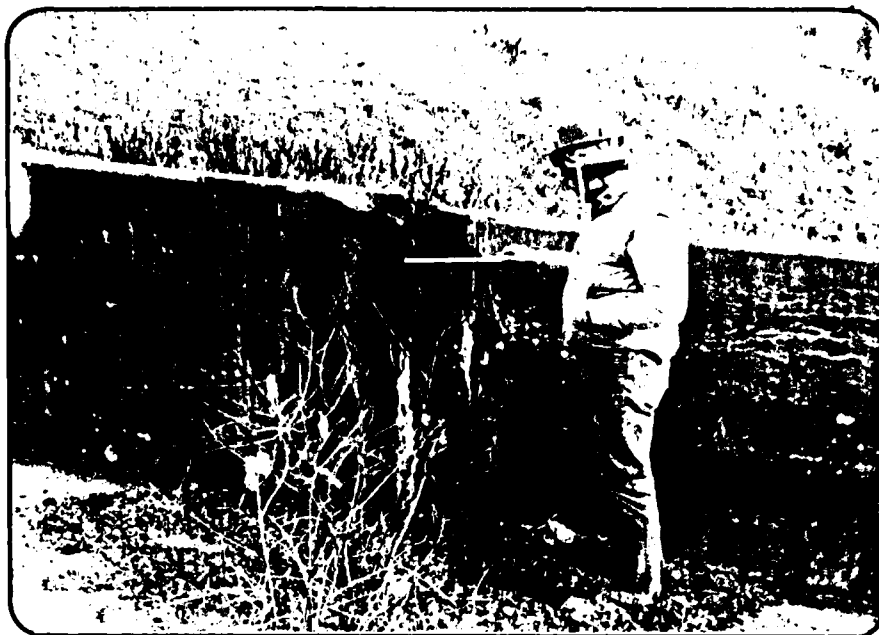
PHOTO 5. Close-up View of Spillway Training Wall Joint

The joints and end sill should be repaired to prevent further deterioration.

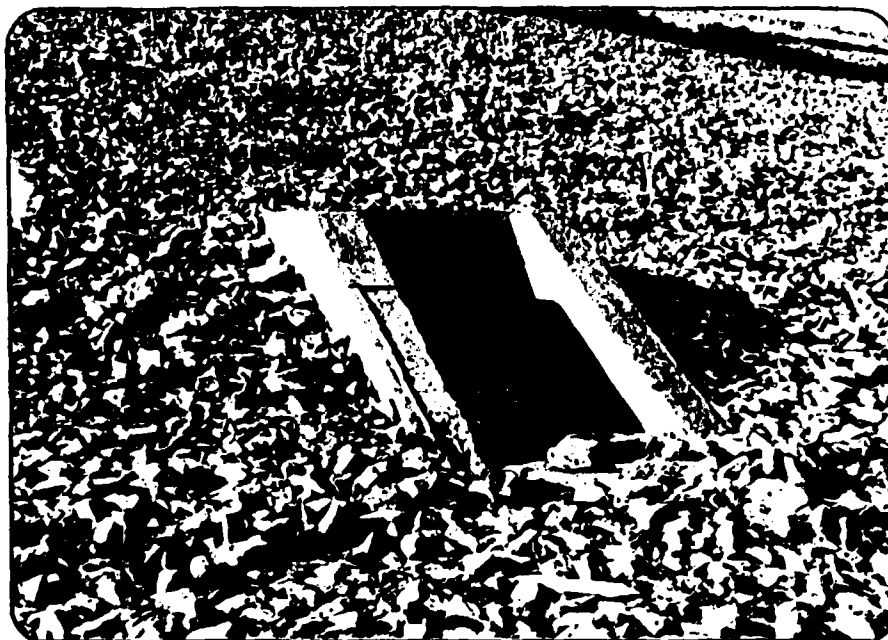
PHOTO 7. View of Upper Level Water Intake
